**INDIVIDUAL PROPERTY/DISTRICT
MARYLAND HISTORICAL TRUST
INTERNAL NR-ELIGIBILITY REVIEW FORM**

Property/District Name: Milton Mealey Farmstead Survey Number: F-5-98
 Project: New Market Loop 230 kV Transmission Line Agency: DNR/PSC
 Site visit by MHT Staff: X no yes Name Date
 Eligibility recommended X Eligibility **not** recommended
 Criteria: A B XC D Considerations: A B C D E F G None
 Justification for decision: (Use continuation sheet if necessary and attach map)

F-5-98
Milton Mealey Farmstead
New Market vicinity
Private

historic Milton Mealey Farmstead

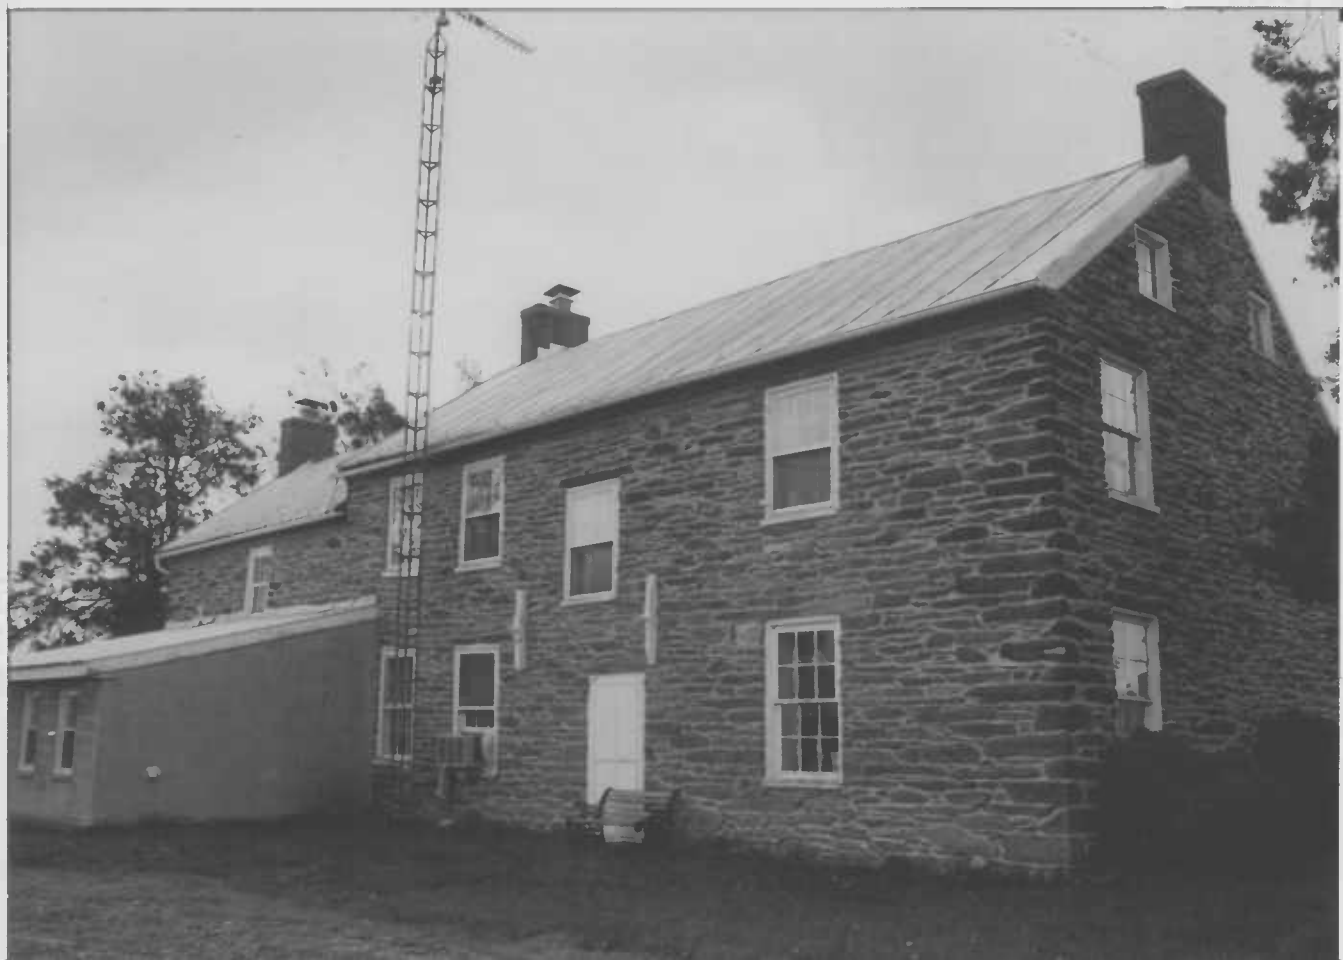
1-5-73

North elevation

The exterior of the western section has five bays on the south elevation with a modern entry porch at the center doorway. On the north elevation, the two sections of the house are joined on a single plane with no evidence of a joint line or other indication of two periods of construction. The roof of the eastern section is slightly lower than the western section roof. Both are covered with standing seam metal over wood shingles. The western section has a corbeled brick cornice and interior end chimneys. The stone exterior walls have been repointed in the 1980's, duplicating the slightly raised profile of mortar joints on other early 19th century stone houses in Frederick County. On the south elevation, the windows are 6/6 and the shutter hardware still in place at some openings indicates that the shutters

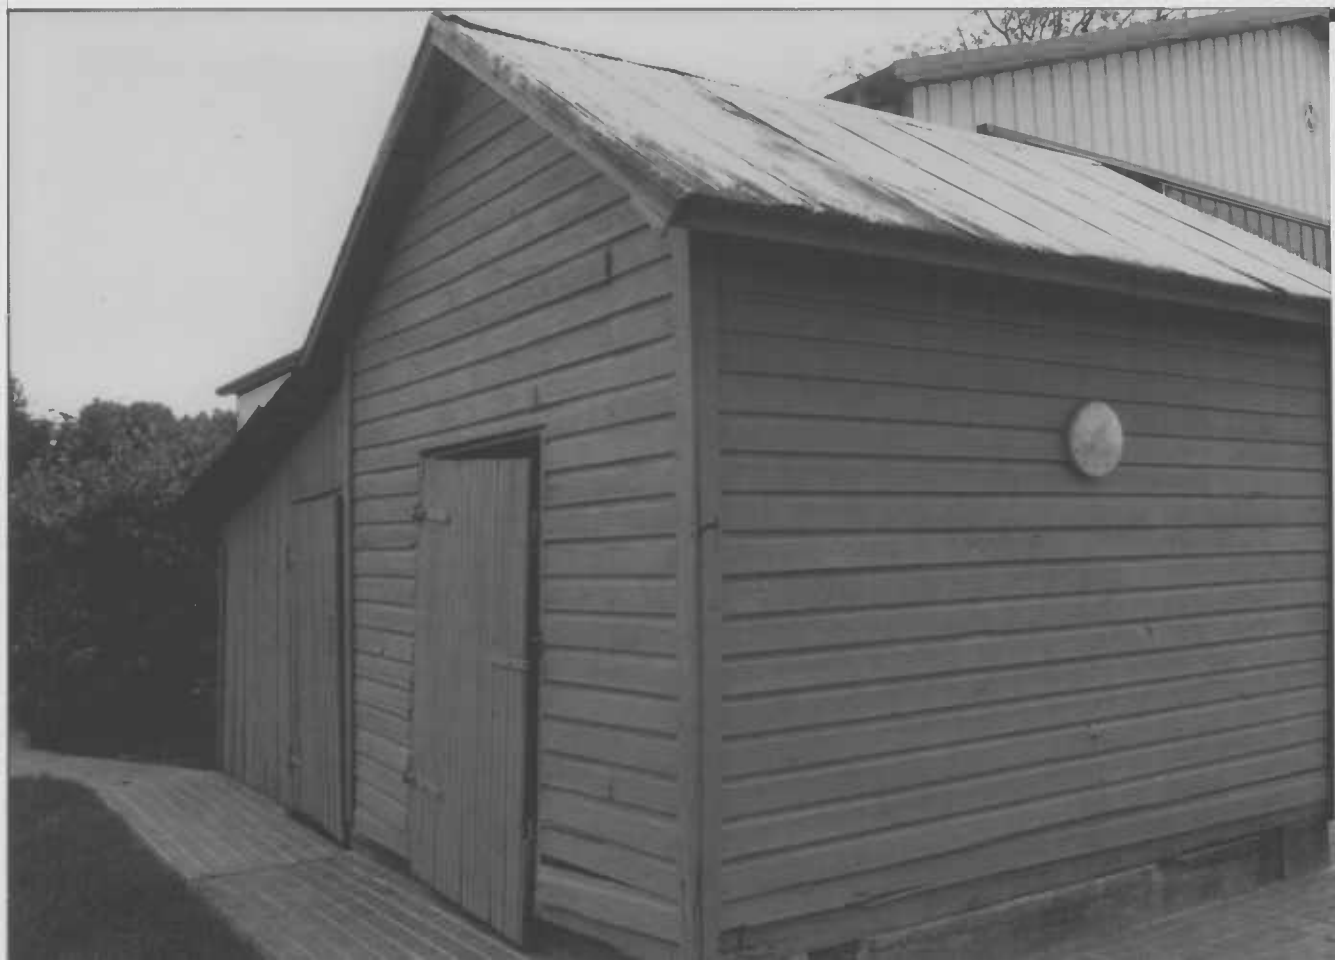
F. 5. 7/8

View of the smokehouse and a red shed, view from
South.

Smokehouse: The circa 1900 frame smokehouse is located northeast of the dwelling's concrete block addition. It has german siding and a tongue-and-groove door on the west gable end. The roof is covered with corrugated metal. A shed addition on the north side is used as a wood shed.
